Česká geologická služba | Czech Geological Survey

METHODOLOGY FOR THE AREA ASSESSMENT IN TERMS OF DEBRIS FLOW HAZARD **USING INNOVATIVE TECHNOLOGY**

Challenge Fund, within the Czech-UNDP Partnership (CUP) for Sustainable Development Goals between the Czech Development Agency and the United Nations Development Program has supported this project. The project brings expertise in the prevention of natural and geological hazards in the high mountain region of Kazbegi in northern Georgia.

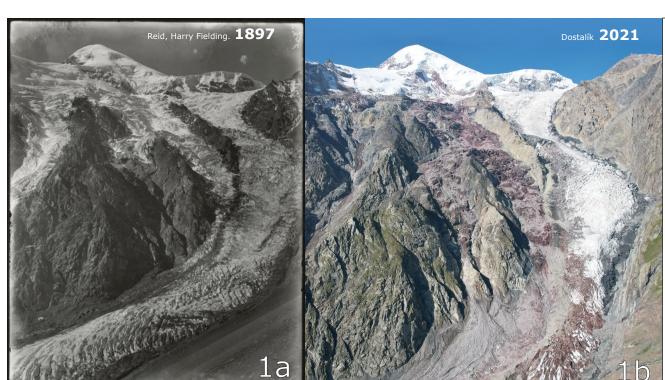
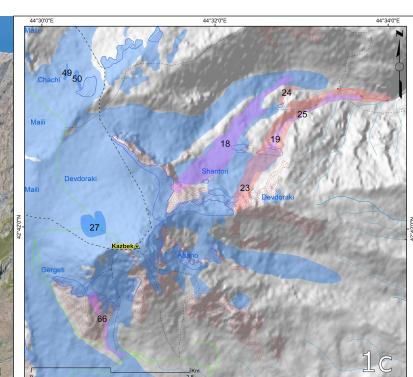
Devdoraki Glacier

The biggest threat in this region is the valley of the Devdoraki glacier. And that's why our first reconnaissance trip was right here. By analyzing the available satellite images (especially Sentinel 2), we registered all rock and glacial avalanches that were captured by satellite imagery. This layer is an important part of the geological hazard map, as it shows places with increased activity that need to be further monitored (Fig. 1c and Table 1). The area ranges of some landslides are shown in Fig. 1c. And numbers correspond to the numbers in the table below.

2004				
No.	year / period	affected area (km²)	length (km)	Туре	
18	2010	0,73	3	ice-rock fall	
19	19.4 - 5.5 2013	0,75	3,8	rock fall	
20	17.05.2014	3,7	10,9	kolaps ledovce / ledovcový - kamenitý přívalový proud	
23	09.0616.06.2019	0,2	1,1	rock fall	
24	3. 11. 2019 - 16. 11. 2019	0,018	0,4	rock fall	
25	3. 2. 2021 - 29. 4.2021	0,125	1,8	ice-rock fall	
26	2014 - still ongoing		·	glacier surge	
27	31.08.2021	0,126	0,4	snow avalanch	
66	1. 10. 2010 - 8. 11. 2011	0,088	1,26	ice-rock fall

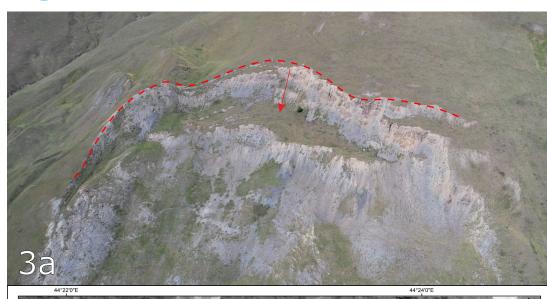
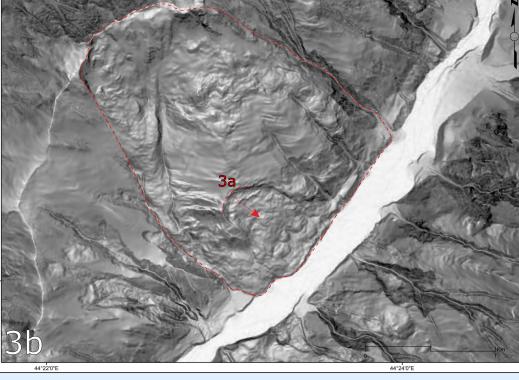
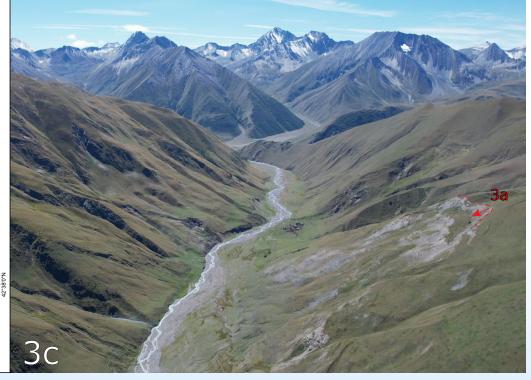
Landslide in the Suatisi Glacier Valley

Deglaciation causes relaxation of the geological environment. The side slopes of the valley are destabilized and slope deformations develop. Here is an example of the Suatisidon river valley. On the right side of this valley, in a weakly metamorphic and heavily weathered shale, a complex deep landslide with active partial landslides has been developed. Figure 3a shows a detail of the 400 m wide scarp area of the partial active landslide at the foot of the slope. Figure 3b is a digital terrain model (slope view) with a resolution of 5m/pixel. The whole complex slope deformation is up to 2.5 km long with an elevation of 1000 m. Figure 3c is a side view of a 920 m long active landslide. In the background is the village of Suatisi.

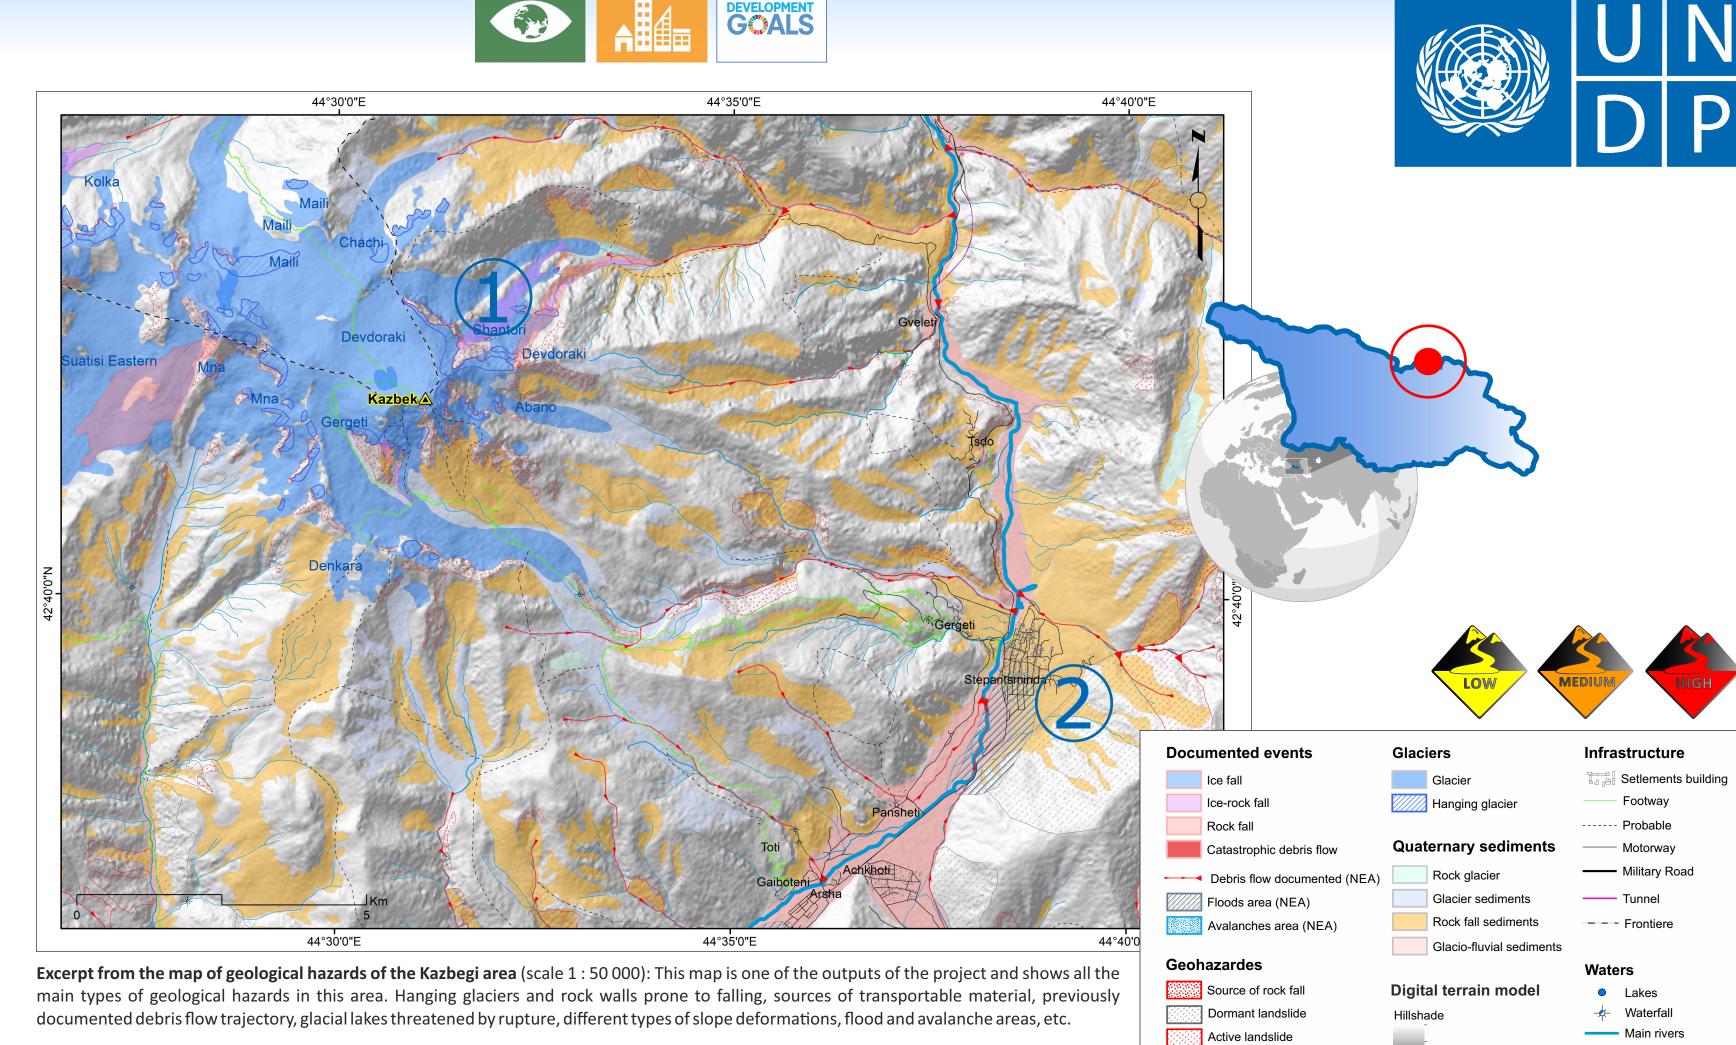
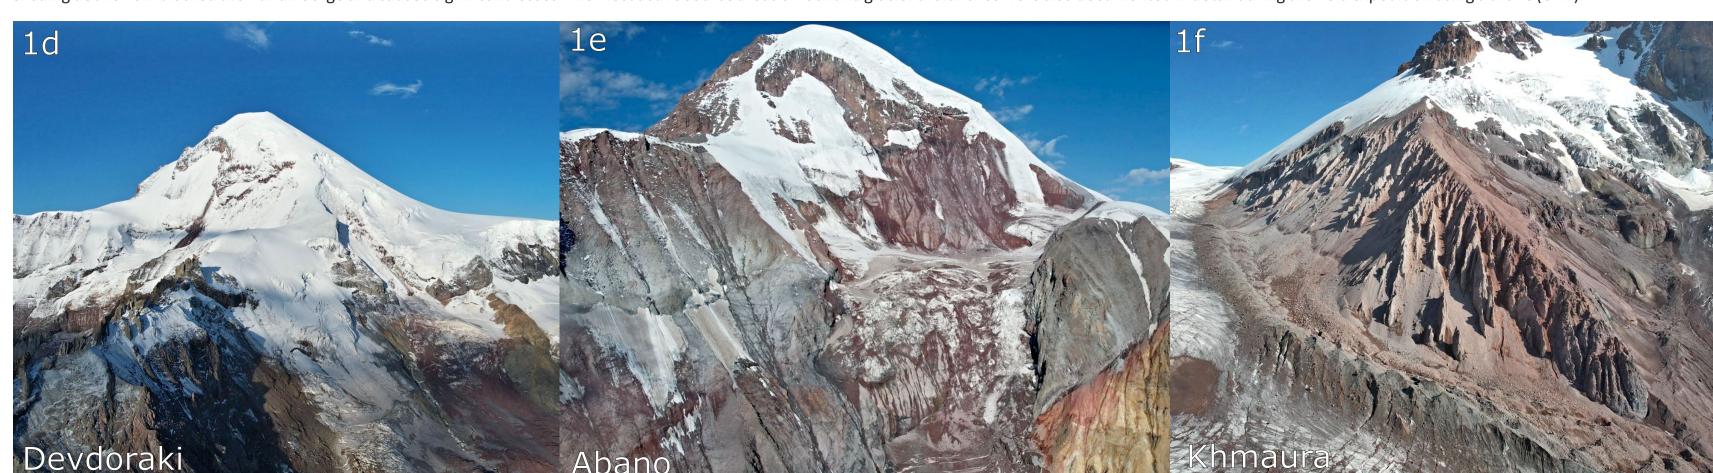
Mapping of hanging glaciers

The key goal of the field expedition was to verify the condition and stability of the hanging glaciers on Mount Kazbek. Rock falls and the collapse of hanging glaciers are the main initial factors in the emergence of catastrophic debris flows not only here. Most of these historically recorded tragic events in the area were caused by the detachment of a mountain glacier. Including the tragedy of 2014, when a huge block of hanging glaciers and rocks collapsed. The ensuing debris flow blocked the Dariali Gorge and caused significant losses. The most active source areas of rock and glacier avalanches were also documented in detail during the field expedition using a drone (UAV).

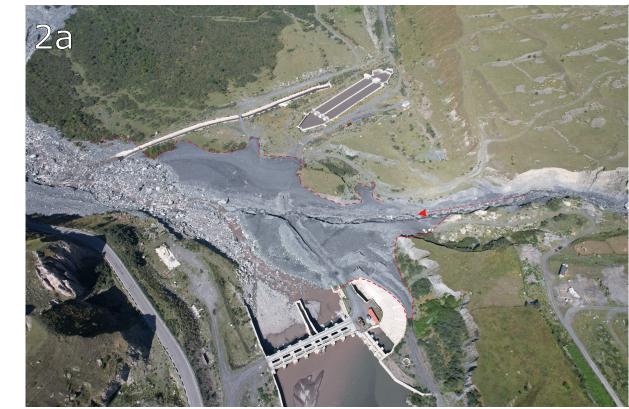
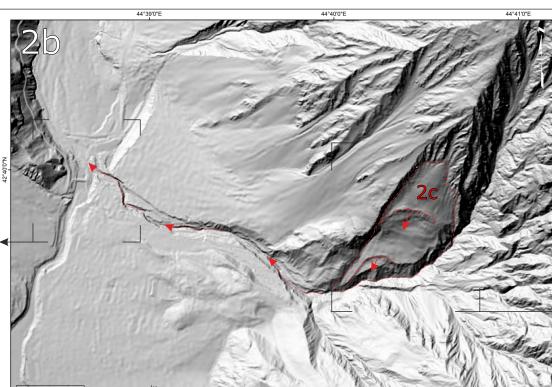
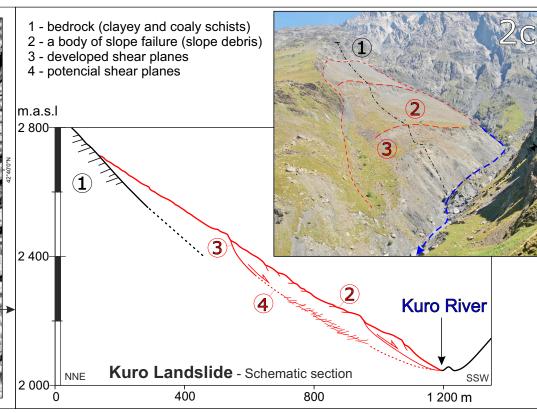
Debris Flow on the Kuro River

The Kuro River is a tributary of the Terek River, which drains the entire territory towards Russia. The Dariali hydroelectric power plant was built at the confluence of these two rivers, despite the fact that this place is periodically affected by debris/mud flows. Figure 2a shows the accumulation of the last event of September 2021, which covered and damaged the HPP structure. The huge rock amphitheater of clayey and coaly schists is the source of a huge amount of material. It is regularly transported to the estuary in the form of debris / mud flow. The transported material is also sponsored by the active landslide of the debris cone on the left bank of the Kuro River. Which is continuously undereroded and constantly contributes other clastic sediments to the river bed (Figs. 2b and 2c). Fig. 2b is a digital terrain model with a resolution of 5m/pixel. The Kuro riverbed is also crossed by two strategic large-capacity gas pipelines, which are in real danger and are planned to be relocated in the future.
